### G503 WWII Jeep Replacing Brake Light Switch

A common problem when your G503 WWII Jeep Brake Light no longer works is that the switch on the Master Cylinder has gone bad. It is not expensive or difficult to replace, here are the steps

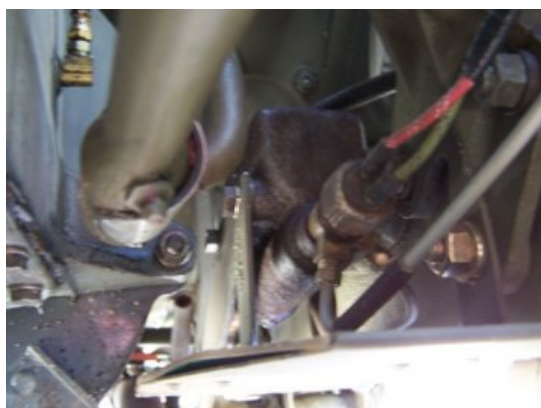
The brake light switch is a common point of failure. The brake light switch is found on the front of the master brake cylinder. There are two ways the brake light switch can fail. 1) pressing the brakes with the light switch on, and nothing lights up. 2) the brake light staying on when the electric light switch is on.

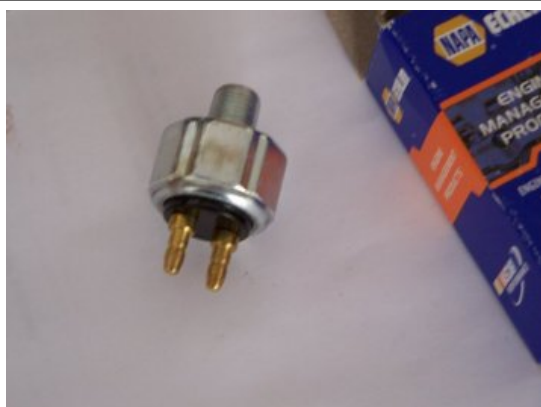
The brake light switch is about \$7 bucks from Napa or from Ron Fitzpatrick G503. I will get them from Ron, unless I am pressed for time.

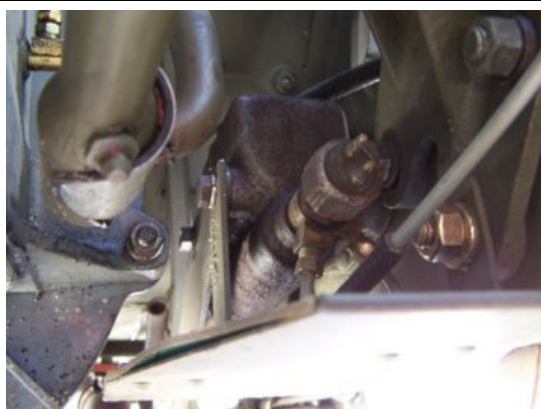
First you want to remove the wires by pulling them off of the terminal on the current switch. If you have a heat shield installed, you are pressed for room and visibility is not that great.

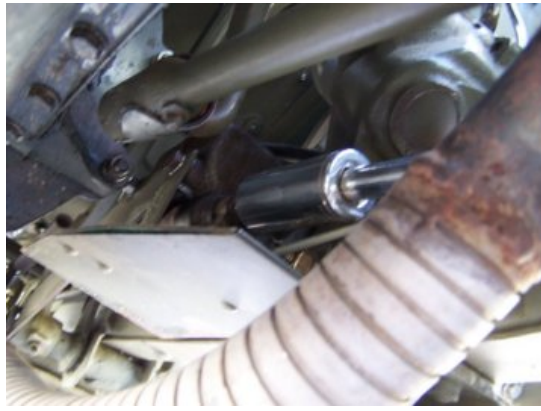
put the 1 inch socket around the old switch and crank it counter clockwise. It takes about a full turn before I can unscrew it with my hand.

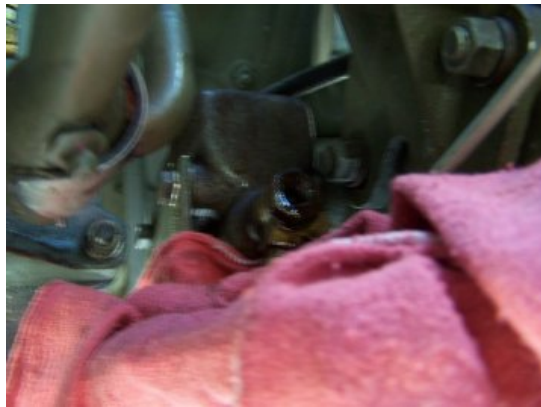
With the old brake light switch off, I want to clean around the area and inspect as best I can. I will use a LED pen light to snoop around and look for any issues.

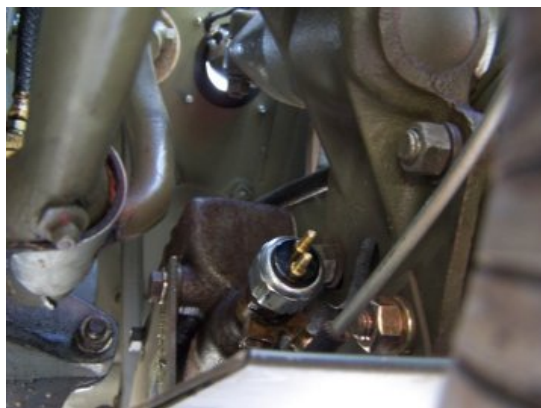
Here I have replaced the switch with my 1 inch socket cranking it on in a clockwise rotation.
