### G503 WWII Jeep Hull Streamline Bakelite Compass Restore

One great tool that is enjoyed on the WWII Jeep is the Hull Streamline auto compass. It adds history and elegance to your historical offroad vehicle. Here are some details on how to restore this cool compass

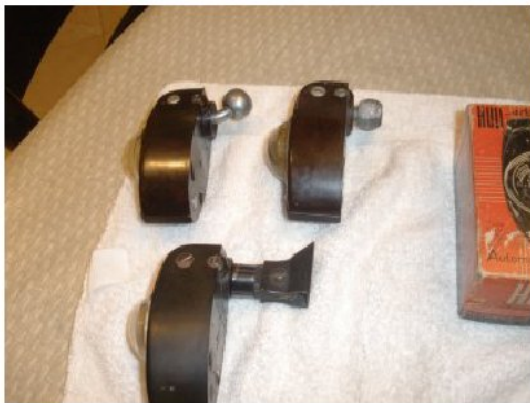
There are a couple different type of WWII Hull Streamline compass that are the correct for the WWII time period. Here you see three brown or black bakelite face plates that are the same

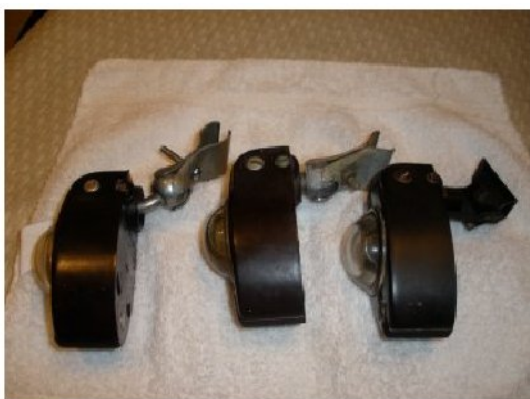
Turning these on their sides you can see a few differences. The arms that hold the compass to a Windshield or Dash, and two the screws to dismantle the magnets for the N-S and E-W screws

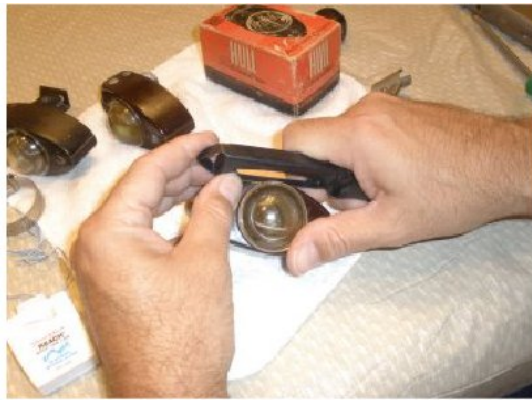
There are two different types of hinges as shown. Two which have different arms and have a clamp style and the third is mounted to a surface via screws.

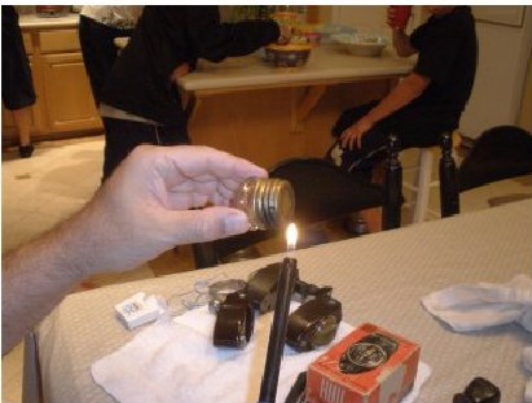
When the glass bulb pops out, you most likely will have some of the fluid all over the device from leakage. Most leak, or are short of fluid.

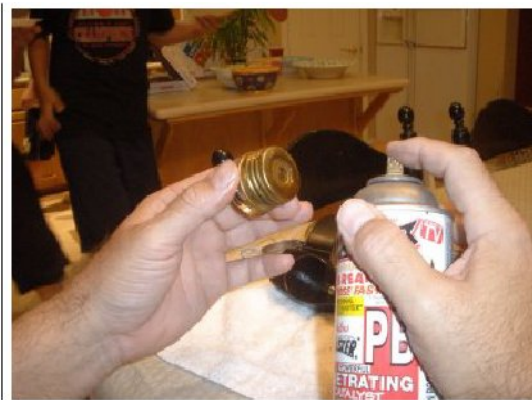
You should be able to unscrew the brass container from the glass, but these are usually frozen on there. You can heat the back and try and get it to unfreeze, Or....

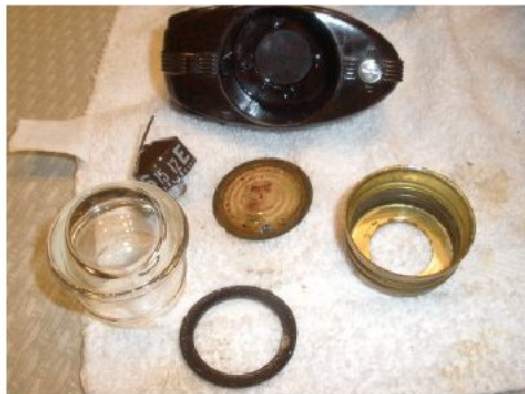
Here is a close up of what you are trying to resolve. There is a brass back plate that is usually frozen to the brass retainer.

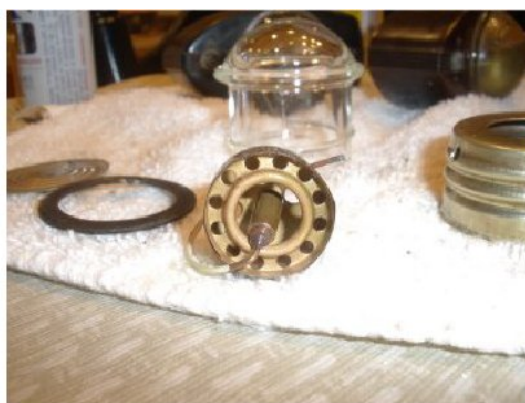
In this case you will see that the small brass "C" shaped wire broke from the back brass plate.

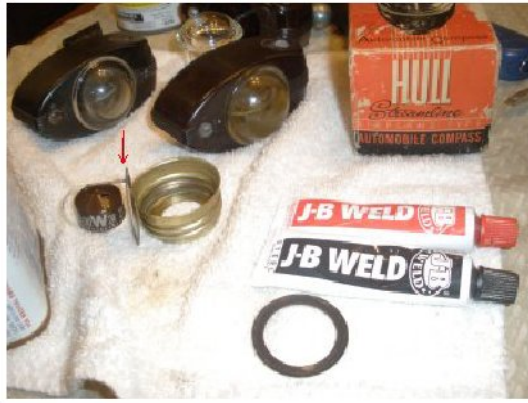
Here is a look at the bottom side of the compass spool for reference
