G503 WWII Military Jeep Radiator Rebuild Restore WW2 Restoration

This article shows a step by step process of restoring your G503 WWII Jeep Radiator - By Lew Ladwig

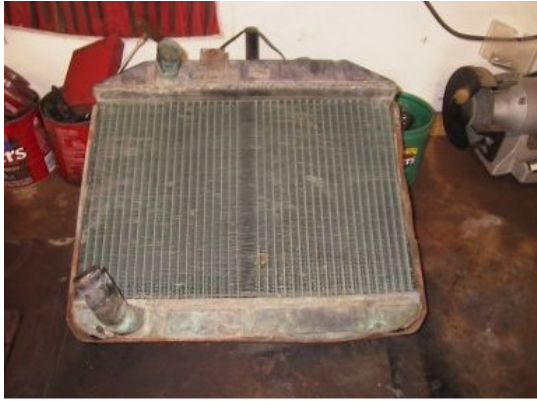
I found a good GPW radiator. Most of the thin fins are bent over but the tubes look to be OK. It has the correct 45 cut on the sides and the center missing tube. The tanks have several dents and the bottom tank is bulged out. This is probably due to freezing. My plan is: 1) Measure frame 2) remove frame 3) remove tanks 4) clean and rod 5) pound out tank dents etc. 6) straighten fins - remove tarnish 7) resolder 8) add shroud 9) add over flow tube 10) paint 11) zinc plate carriage bolts

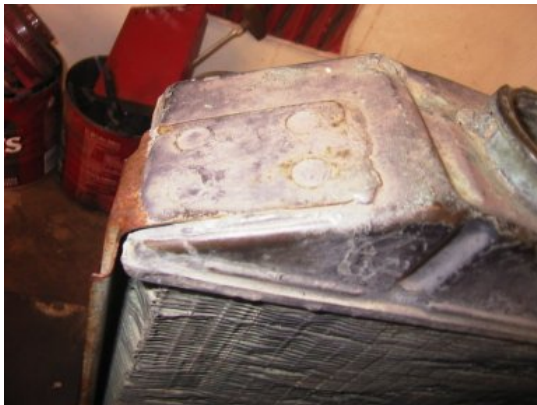
You can see where the frame is soldered to the top tank, there is also solder along the bottom and the lower corner tabs. Mine had broken the solder joint at the corners and most of the bottom.

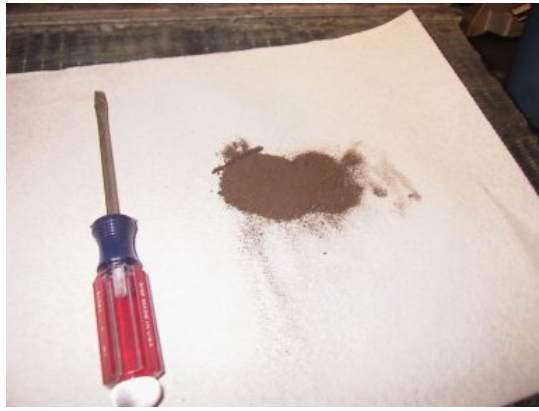
This is about 1/3 of the dirt from the bottom tank:

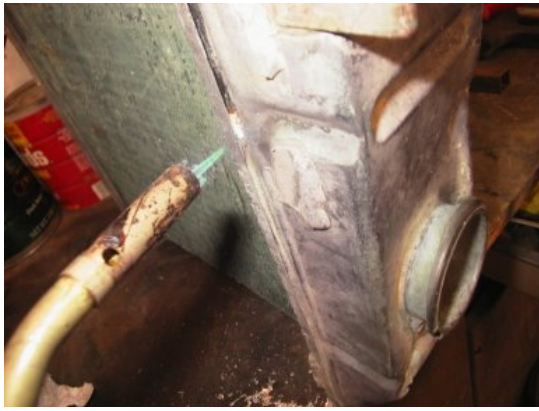
Work your way down and be sure you get it all out. Use a putty knife or screw driver to separate the parts:

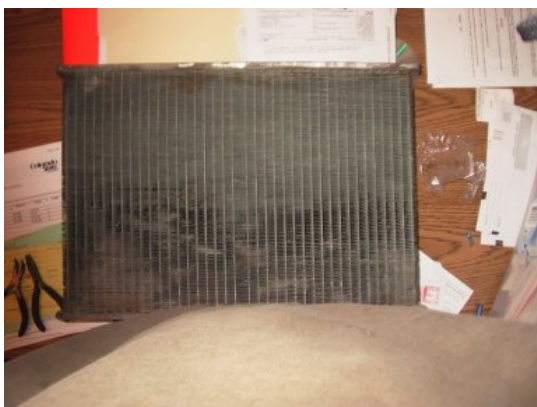
Next, after washing the core, I started to straighten the fins and tubes. I used a small pair of thin flat bladed pliers. You can see in the picture my first pass over the upper half of the fins. Still need to do the lower, ends, and other side: I think I wil give it all a muratic flush when I'm done. Then a bit of a rinse in baking soda water to neutralize the acid, and a good soapy water rinse.

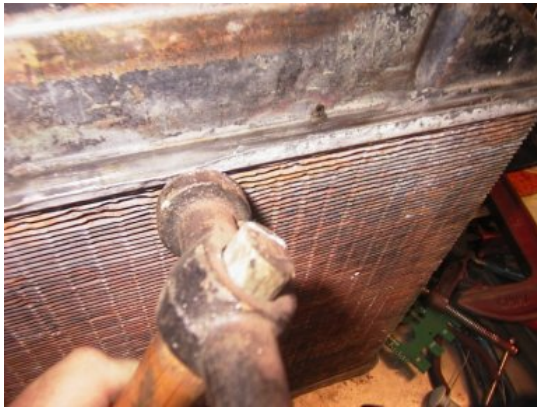
Then I worked on fitting the top tank to the core. I made sure it sits full depth. You may have to remove some solder from the top of the core to get the tank to sit correctly. Once in place I started tapping the core lip tight to the tank. Be careful not to push the tank sides inward when doing this. OH, I forgot, put tinning flux along the entire seam.

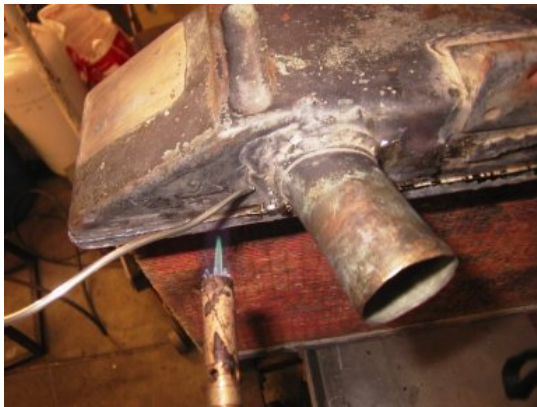
Then I soldered the seam closed. If you did a good job on the prep work the heat will suck solder into the seam. Be careful that you don't overdo the solder as it will flow into the tank and build up inside. I like to move along steady and get it to flow and once flowing move on. I double back and fill the top edge to be sure but only to the point it starts to flow.

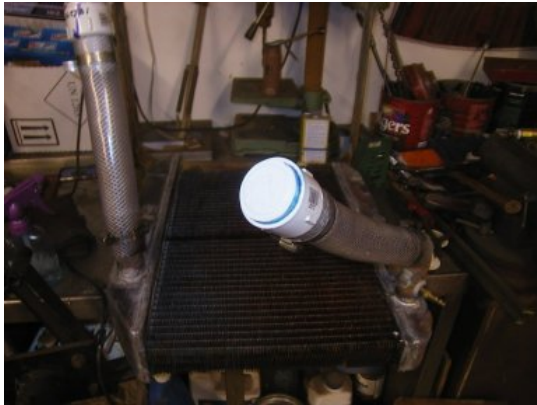
I set up my pressure testing method. I installed a hose over each pipe with a cap on the ends. I then put a standard air chuck fitting in the petcock hole. Installed a cap on the fill port. Hooked it up to my air compressor and charged it up until the air started leaking out the pressure cap. This was about 7 lbs.. I then checked for leaks with soapy water. I could have used a tub with water but did not want to do that just yet.

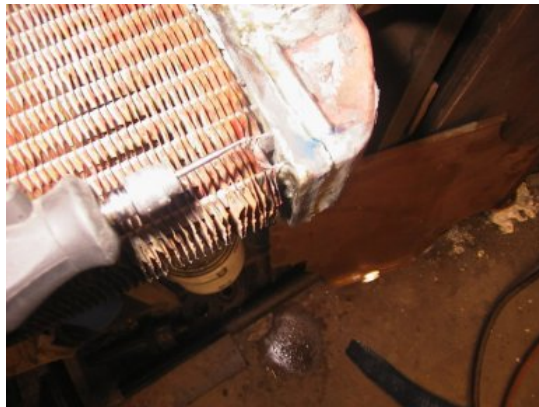
I cleaned the area with my dremil tool.

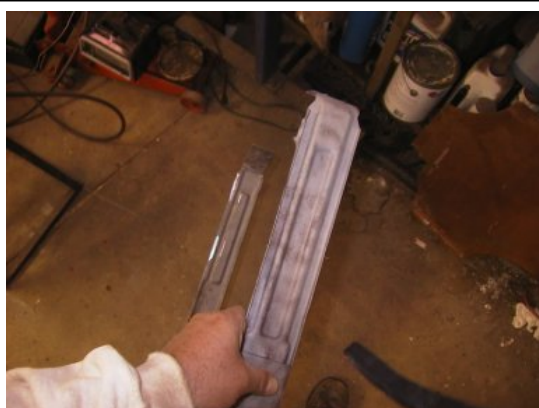
Here you see the frame is blasted

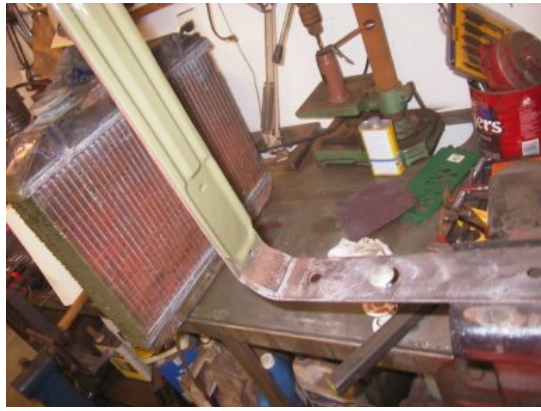
Don't forget the mounting bolts! Mine are a tight fit in the half moon so I put them in ahead of time.

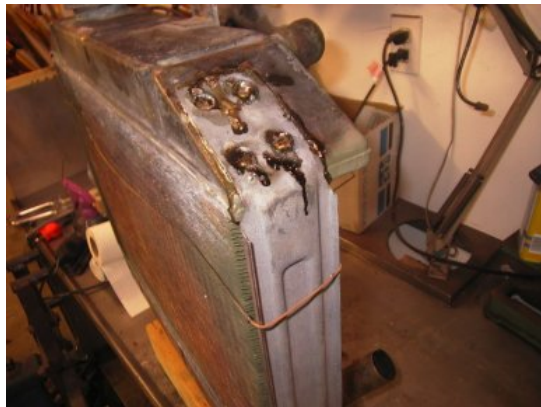
Start at one end and work around. Edge is 1/4" in from the front.

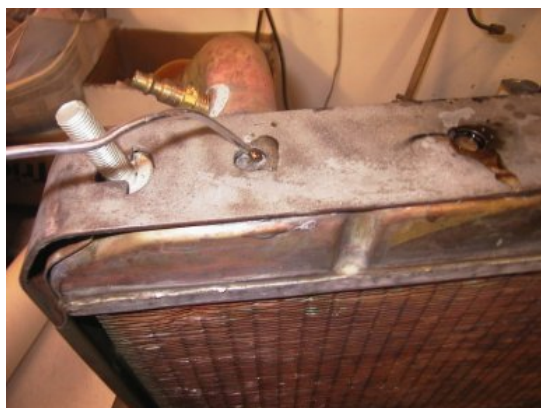
Use the access holes on the bottom to get good bonding.

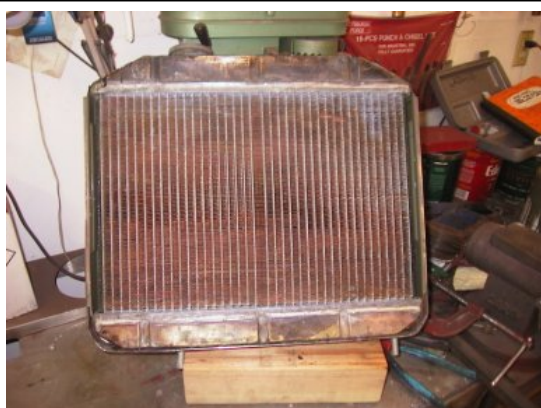
...and the frame is done!

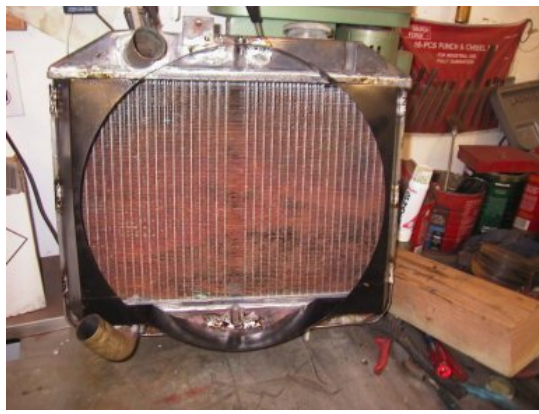
Shroud fitted and soldered as per original spots:

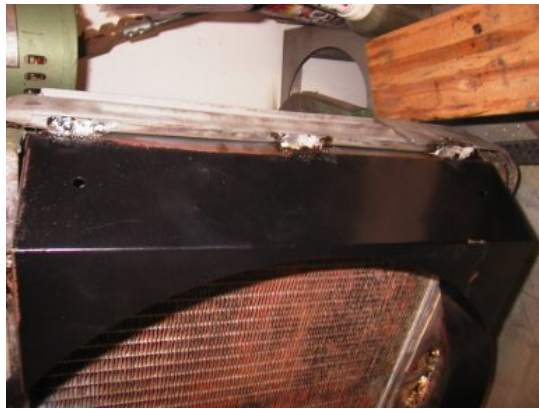
Spots down side...I don't know if you noticed but I prepainted the inside of the frame where there would not be any soldering. I also got the fins painted down the sides. Probably not factory but with this area being near the battery I wanted some protection.

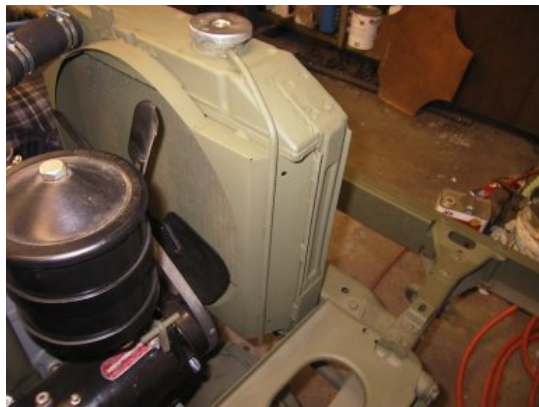
Here I installed the overflow tube. I flared the end to fit over the nipple on the neck.

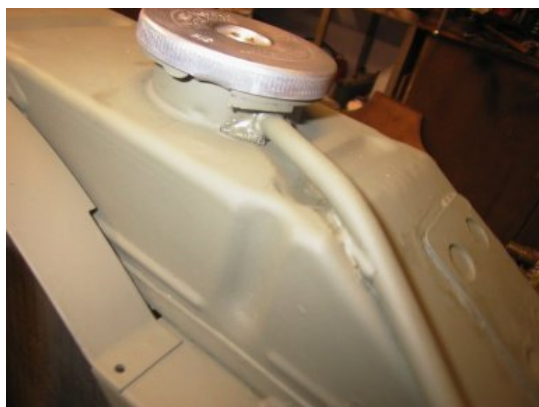
It gets soldered at the neck and on top and a few down the side.

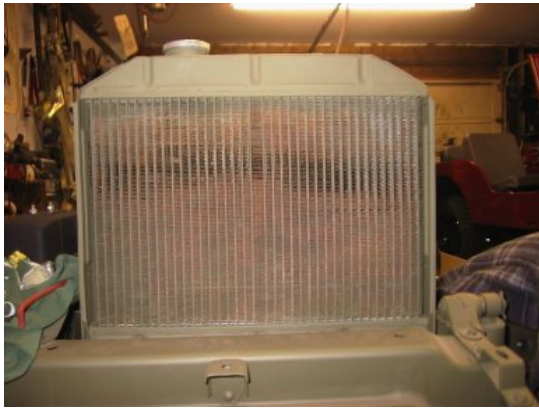
I think it came out well. I gave the whole unit a coat of OD after wiping it all down with acetone to get flux off.
